Structural Analysis of DEW Line Station DYE-2, Greenland 1983-1988

Michael R. Walsh and Herbert T. Ueda

June 1998

CRREL Report 98-3

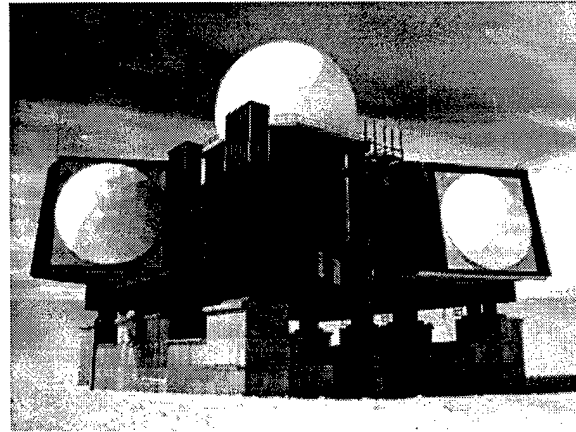
Figure 3. DYE-2: 1977.

During the intervening years, the column foundations had been distorted by differential settlement due to the nature of the supporting snow. The foundation distortions caused secondary stresses to accumulate in the structural frame. In addition, hydrostatic pressure from the surrounding snow became higher as the building was raised and the column length below the snow surface increased. Eventually, the pressure was high enough to begin distorting and crushing the protective wooden enclosures, shown beneath the building in Figure 3.

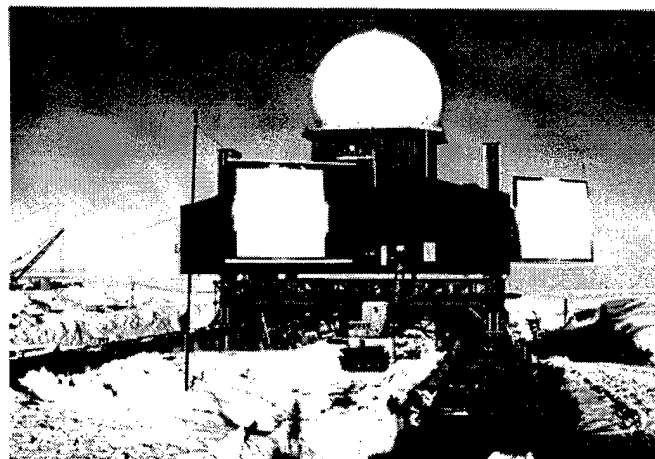
Figure 4. DYE-2 move: 1982.

By the early 1980s, measurements indicated that column stresses were sufficiently high to require drastic remedial action. In 1982, the supporting structure was severed at a new base level, and DYE-2 was moved sideways 64 m onto a new set of footings (Fig. 4). The following year, the building was lifted 8.2 m. Since that time, CRREL personnel monitored building and col-

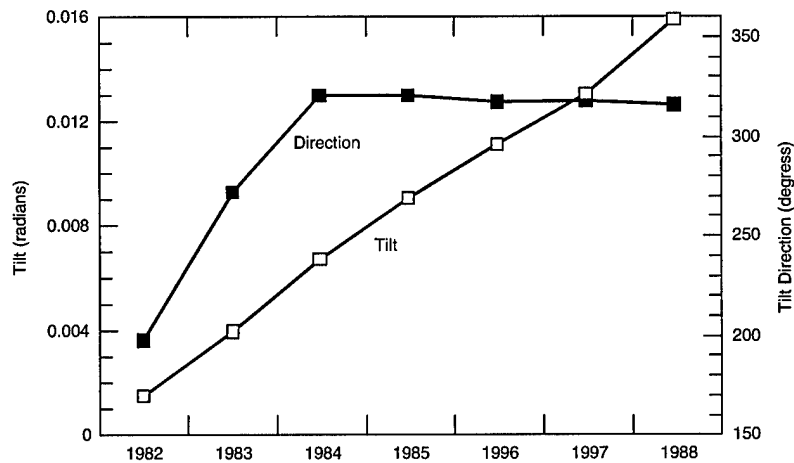
Figure 17. Footing tilt trends.

Footing tilts correlated remarkably well with the settlement data at DYE-2. Table 4 contains resultants and directions for the footing tilt data for the years 1982 through 1988 for each column. Also included are the averages for all columns for each year. This is depicted graphically in Figure 16. Comparing Figure 13 to the data in Table 4 and Figure 16 shows that the footings are tilting in almost the same direction with the same magnitude as the columns: in a direction of 313° with a magnitude of approximately 0.015 radians. These values are too close to be coincidental. The rates of change are also very similar, approximately 0.0025 radians per year. Statistical analysis of the resultant averages shows a very high degree of linearity in the tilt progression: >0.997 .

Figure 17 shows trends for the average tilt and direction for the footings. These should be compared to the footing settlement trends in Figure 14.

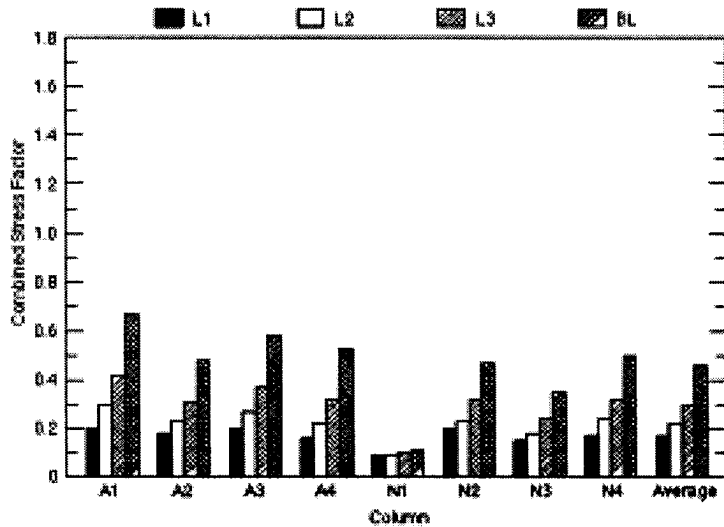
Figure B1. Swaybolt loads: 1983.

Figure B1 contains sway bolt data for the building level only. At the time readings were taken, work was not complete on the 1983 lift operation. Stress factors for other levels are extrapolations from the building level stresses.
